Manhole Inspection Summary

Manhole # S17C__021MH

Location Address: **2520 FRANKLIN ST**

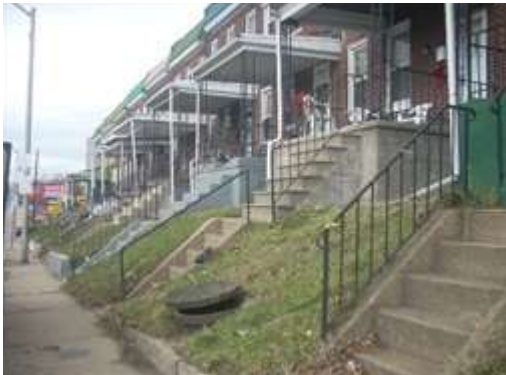
Location View

GRADE ADJUSTMENT

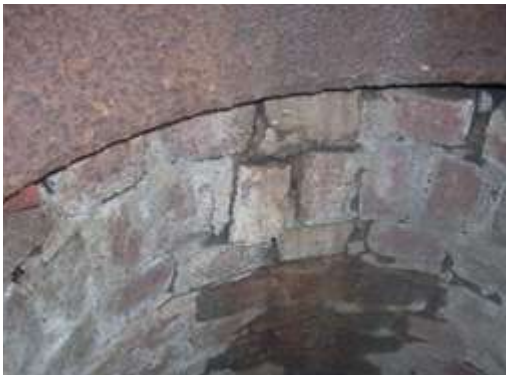
Defect 2

Infiltration: ☐ None ☐ Joint ☐ Cracks ☐ Mortar ☐ Roots ☒ **Wall**

CORBEL INFILTRATION

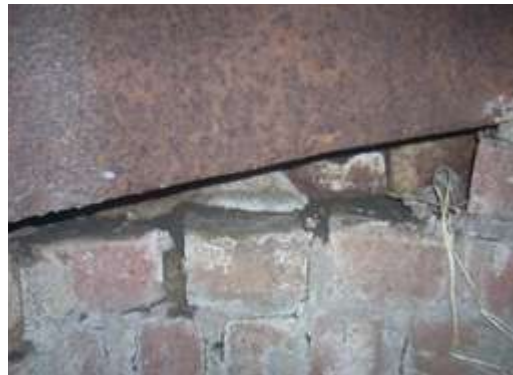
Defect 1

Condition: ☐ Sound ☐ Cracked ☐ Root Intrusion ☐ Loose Brick ☒ **Deteriorated**

DETERIORATED CHIMNEY

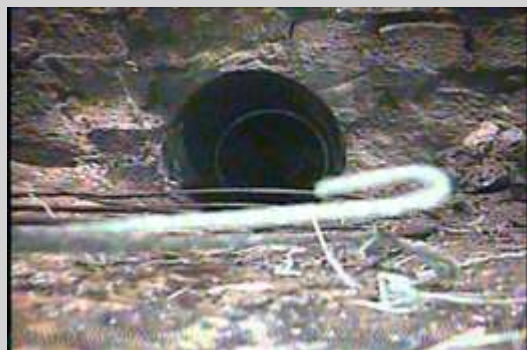
12 O'Clock Outflow

8 in. Circular Gravity Sewer
Pipe Out @ 12 O'Clock

Infiltration: **None** Pipe Seal Cond: **Sound**
